Manhole Inspection Summary

Manhole # S05WW1028MH

Location Address: **5814 WINNER AVE**

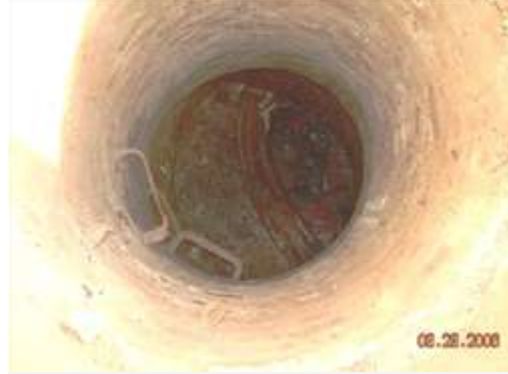
Top View

Evidence of surcharge - Bench debris.
Corroded and missing steps.

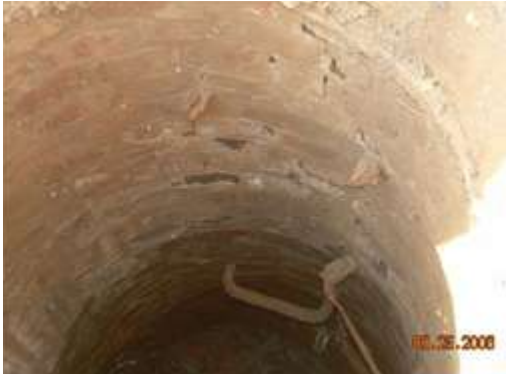
Defect

Frame leaks. Adjustment deterioration
and infiltration. Corbel and Barrel
infiltration. Corroded and missing steps.

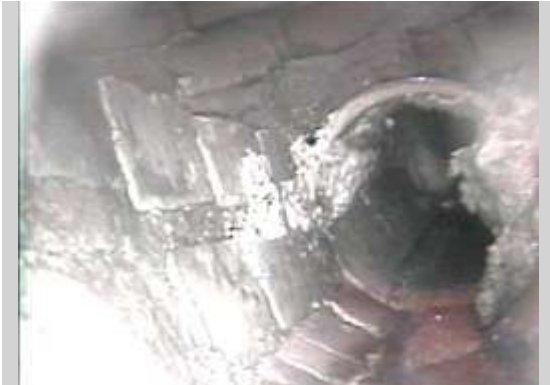
8 in. Circular Gravity Sewer Pipe Out @ 12 O'Clock

Comments **The O12 pipe picture shows grease deposits in the Channel and inside of the pipe.**

Barrel deterioration and infiltration.

Deposits: ☐ None ☐ Mud ☐ Sludge ☐ Debris ☒ Grease

Silt Depth: **0** (in.) Deposits Extent: **Medium**

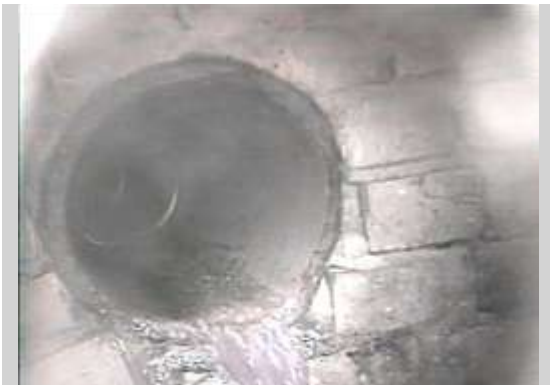
8 in. Circular Gravity Sewer Pipe In @ 4 O'Clock

Infiltration: **Evidence** Pipe Seal Cond: **Cracked**

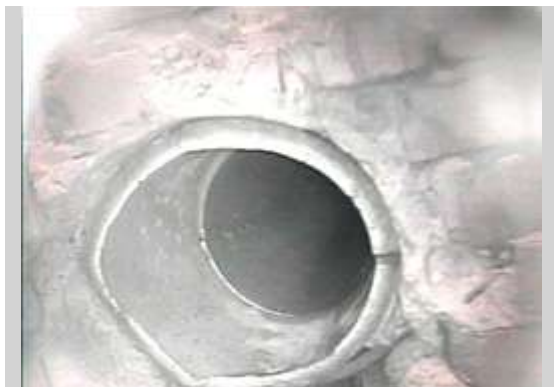
8 in. Circular Gravity Sewer

Infiltration: **Evidence**

Connects To: **Stub connection / abandoned**
